Safety Alert 8: Falling of a precast wall panel in stacking rack

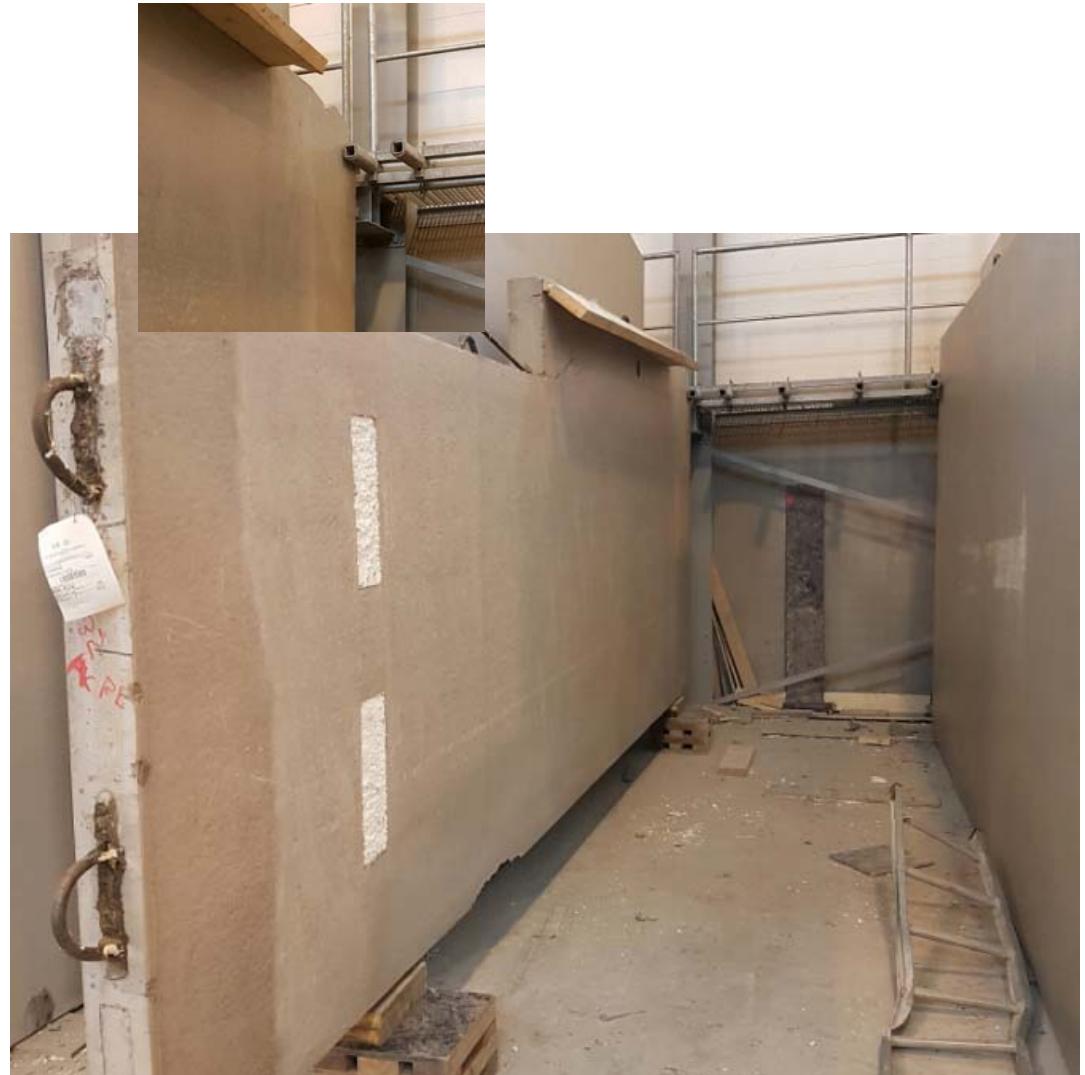
A precast inner leaf (panel which needs to be turned for installation) with a vertical joint pumping groove was stored on top of high wooden blocks so that the top edge of the inner leaf panel could be raised between the pins of the stacking rack.

After a little while the blocks fell over and the panel fell off them. The top edge of the panel fell under the pins of the stacking rack allowing the panel to fall freely against the panel next to it. Both panels were damaged.

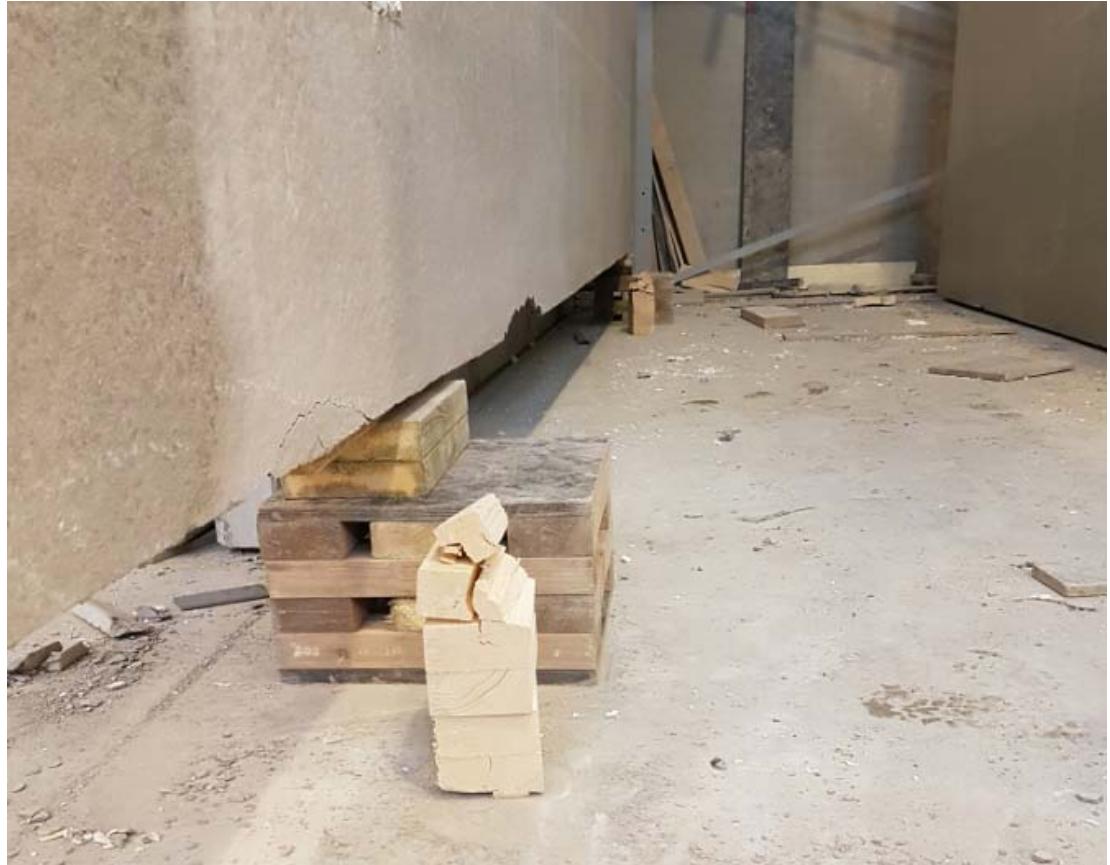
The wooden base blocks 50 x 100 L=200 had been placed longitudinally under the panel at both ends.

The weight of the element rested on the blocks eccentrically due to the groove on the bottom edge.

The blocks became inclined and fell over from under the panel.

The blocks were too narrow with respect to the height of the block stack, and not even the same width as the panel. In addition, they were not placed centrally under the panel.

The photo shows the 50x100 L=200 stacks of wooden blocks which fell over.

The wooden base block must always be at least the same width as the panel.

The height of the stack of blocks may not exceed the width of the blocks.

The base blocks shall be placed crosswise under the panel.

A piece of the groove mold shall be left in place in the groove on the bottom edge by the support points, not to be removed until the panel is loaded in a vehicle for transport to the worksite.

A second row of pins shall be provided at a height of ca. 1.5 m from the floor to avoid the need for high base blocks.
