Safety Alert 8: Falling of a precast wall panel in stacking rack

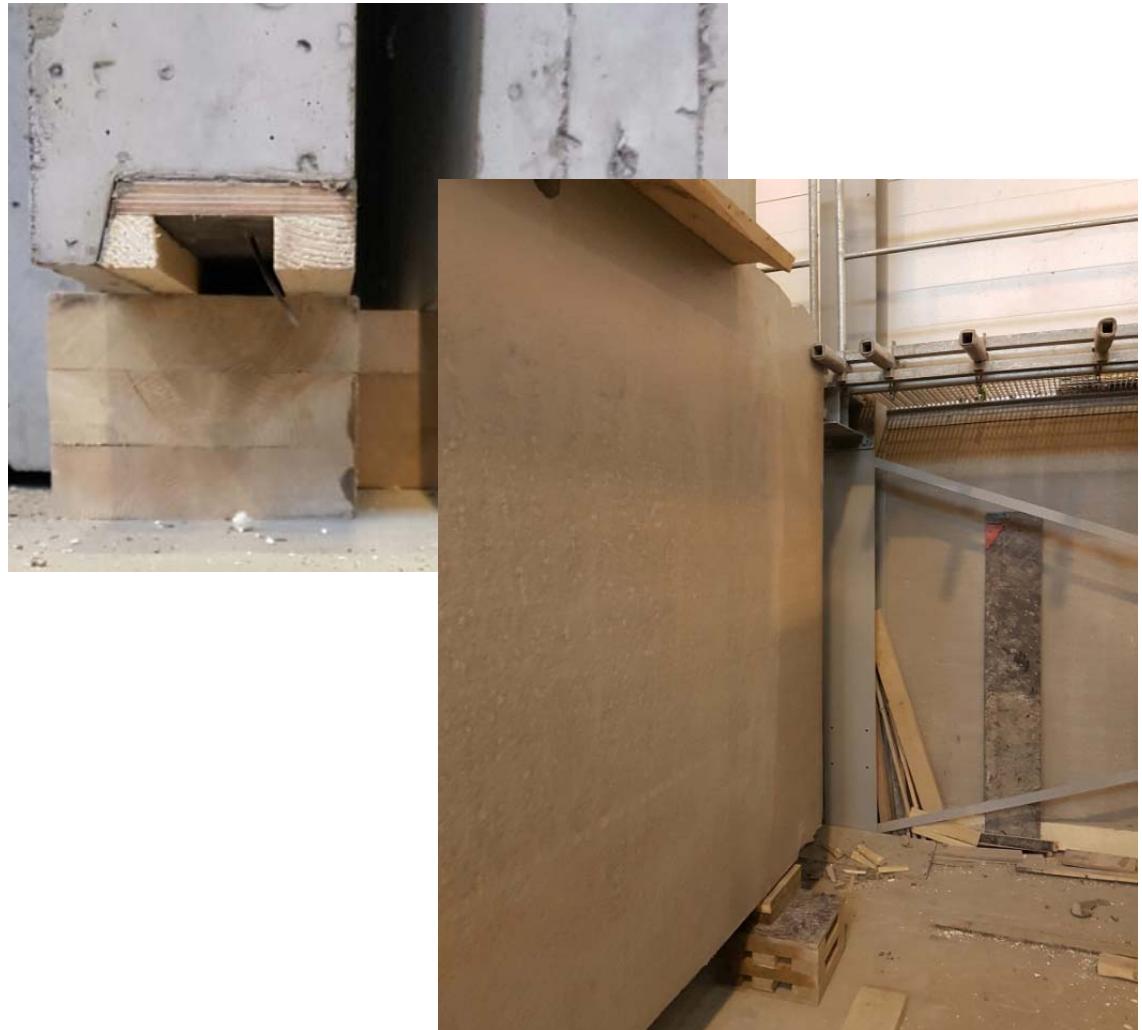
The wooden base blocks 50 x 100 L=200 had been placed longitudinally under the panel at both ends.

The weight of the element rested on the blocks eccentrically due to the groove on the bottom edge.

The blocks became inclined and fell over from under the panel.

The blocks were too narrow with respect to the height of the block stack, and not even the same width as the panel. In addition, they were not placed centrally under the panel.

The wooden base block must always be at least the same width as the panel.

A piece of the groove mold shall be left in place in the groove on the bottom edge by the support points, not to be removed until the panel is loaded in a vehicle for transport to the worksite.

A second row of pins shall be provided at a height of ca. 1.5 m from the floor to avoid the need for high base blocks.
